THE BRICKBUILDER.

THE RECENT FIRE AT PITTSBURGH.

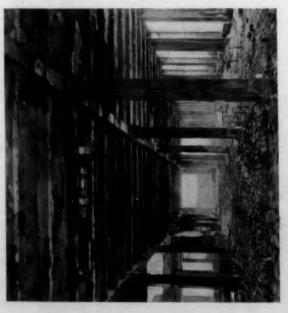
P.IATE 8.—Methodist Episcopal Building with Citizens' Traction Company one-st building, where the fire stopped on the east. Ruins of Jenkins Building on the right.
